## 7EA Experience with Water Cooled Liquid Fuel Check Valves Installed in Dual Fuel Engines

Source: Combined Cycle Journal, Third Quarter 2009

Gainesville Regional Utilities (GRU)

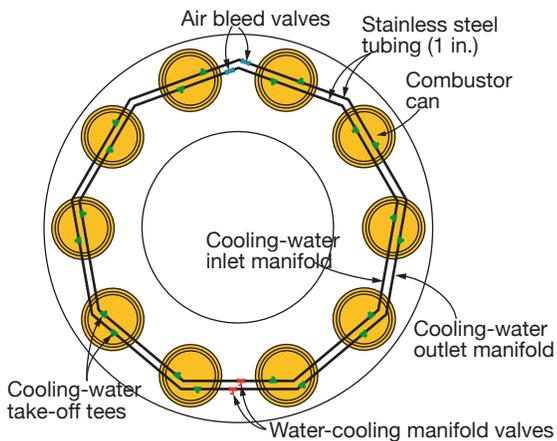
### A. Cooling-water manifolds, supply and return, are made of 1" tubing.

One inch cooling-water supply and return manifolds were installed (Fig A) to serve all combustors in parallel. Fig B shows that cooling water flows to the primary fuel nozzle first and then to the secondary nozzle (in series).

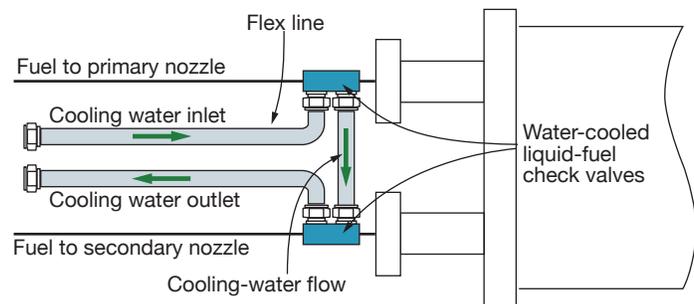
### B. Cooling water flows from primary-fuel check valve to secondary-fuel valve in series.

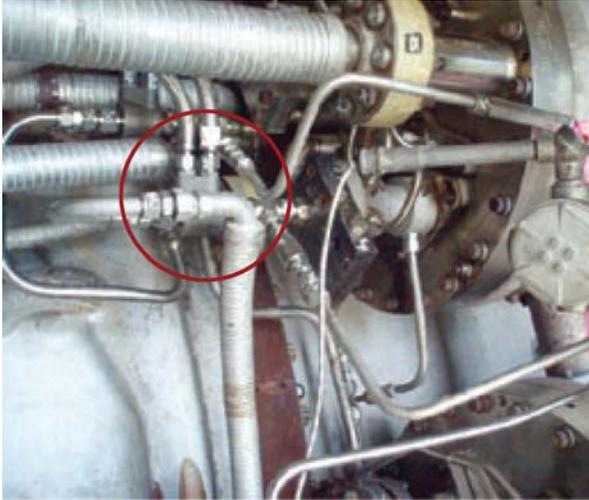
**C. Water-cooled liquid-fuel check valve** is installed with flex hoses on the supply and return lines.

A water-cooled check valve, as installed, is in Fig C, with a drawing to illustrate how the valve works in Fig D.

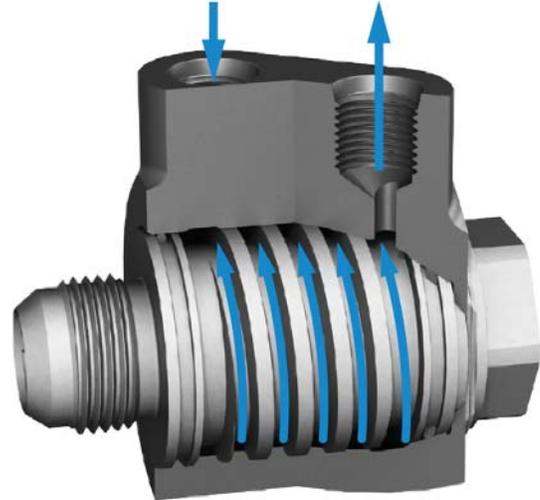
**D. A water jacket** has been added to the standard liquid fuel valve design to eliminate coking on valve internals.

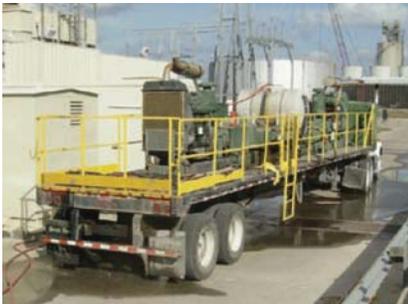
**E. Hydrolazing** is no small task; flatbed holds all equipment required

Cleaning of the fuel system required an effort that should not be underestimated, continued Hollandsworth. He said a holistic approach was used to make sure the job was done properly. Hydrolazing was used to cut through coke in fuel lines and remove it from the system. System clean-up took about a week. Truck with necessary equipment is in Fig E, worker protection required in Fig F. Process gets results: Coke removed is in Fig G.

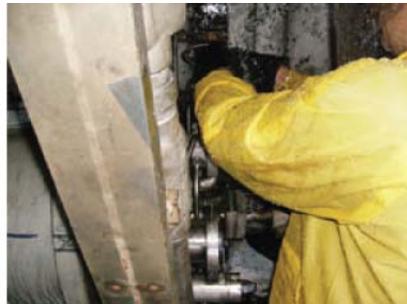
**F. Protective clothing** is required by hydrolaze technicians

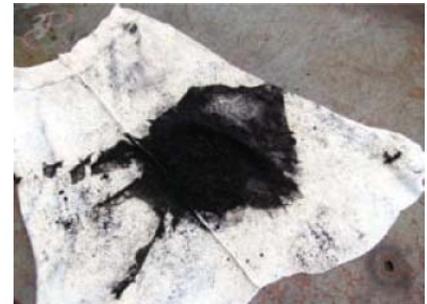
**G. High-pressure water** cuts through the coke and flushes it out

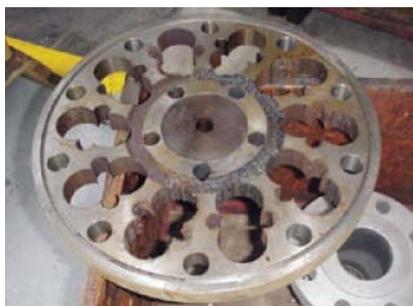
1. The flow divider was gunked up, corroded, and inoperable (Fig H); it was replaced.
2. The selector valve was plugged (Fig I) and refurbished.
3. Purge-air solenoids for the secondary-fuel circuit were found inoperative.

**H. Flow divider**  
was gunked up, corroded and inoperable

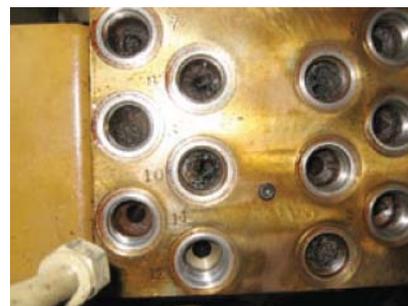
**I. Selector Valve**  
required work to unplug ports
